# METRO THERMAL ASH MONOFILL CLOSURE CAP

## STORMWATER DAMAGE AND RESTORATION UPDATE

# METRO THERMAL ASH MONOFILL

## Metro Nashville Public Works

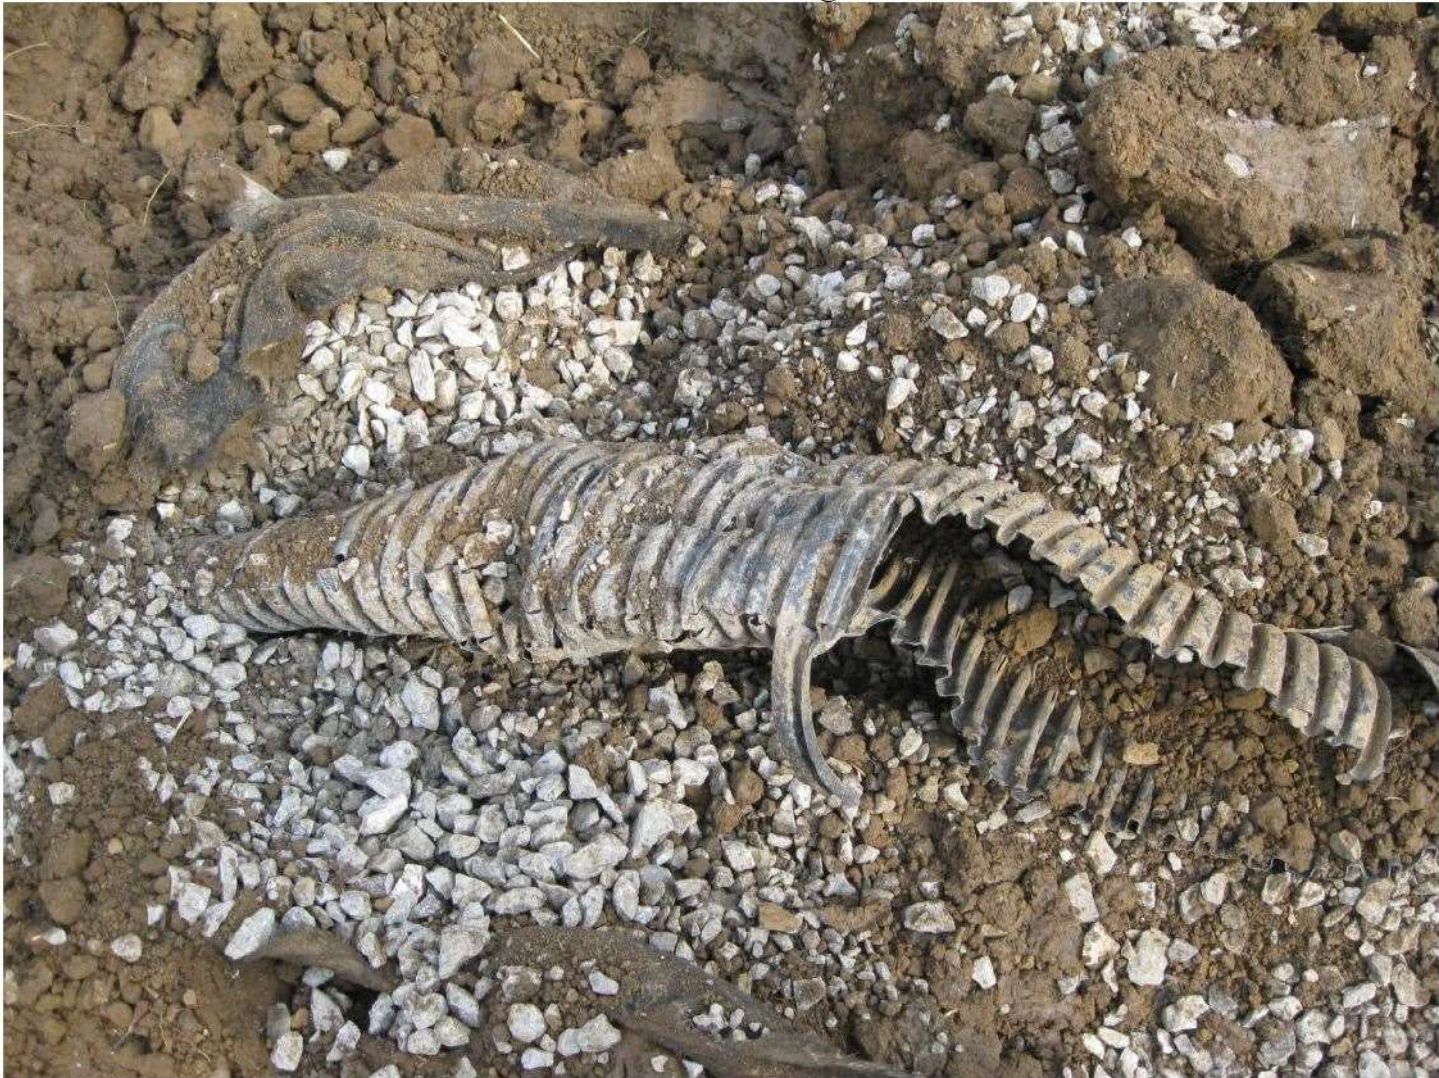
**Subarea-C, underdrain coming from Subarea-D**

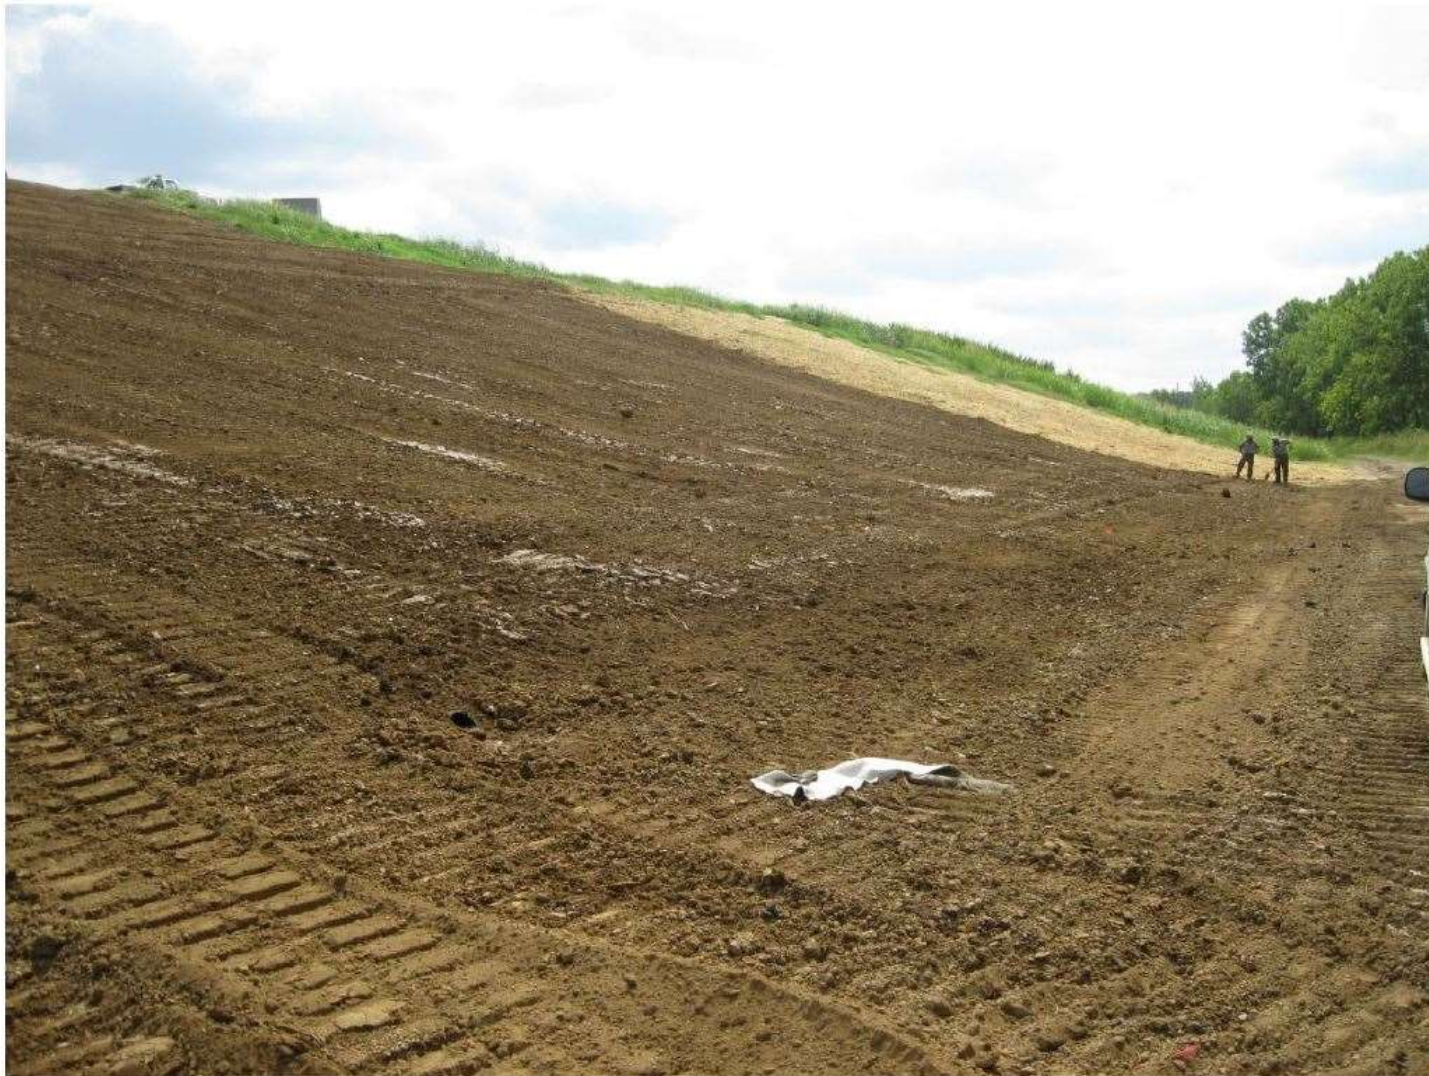
Subarea-C, final grading

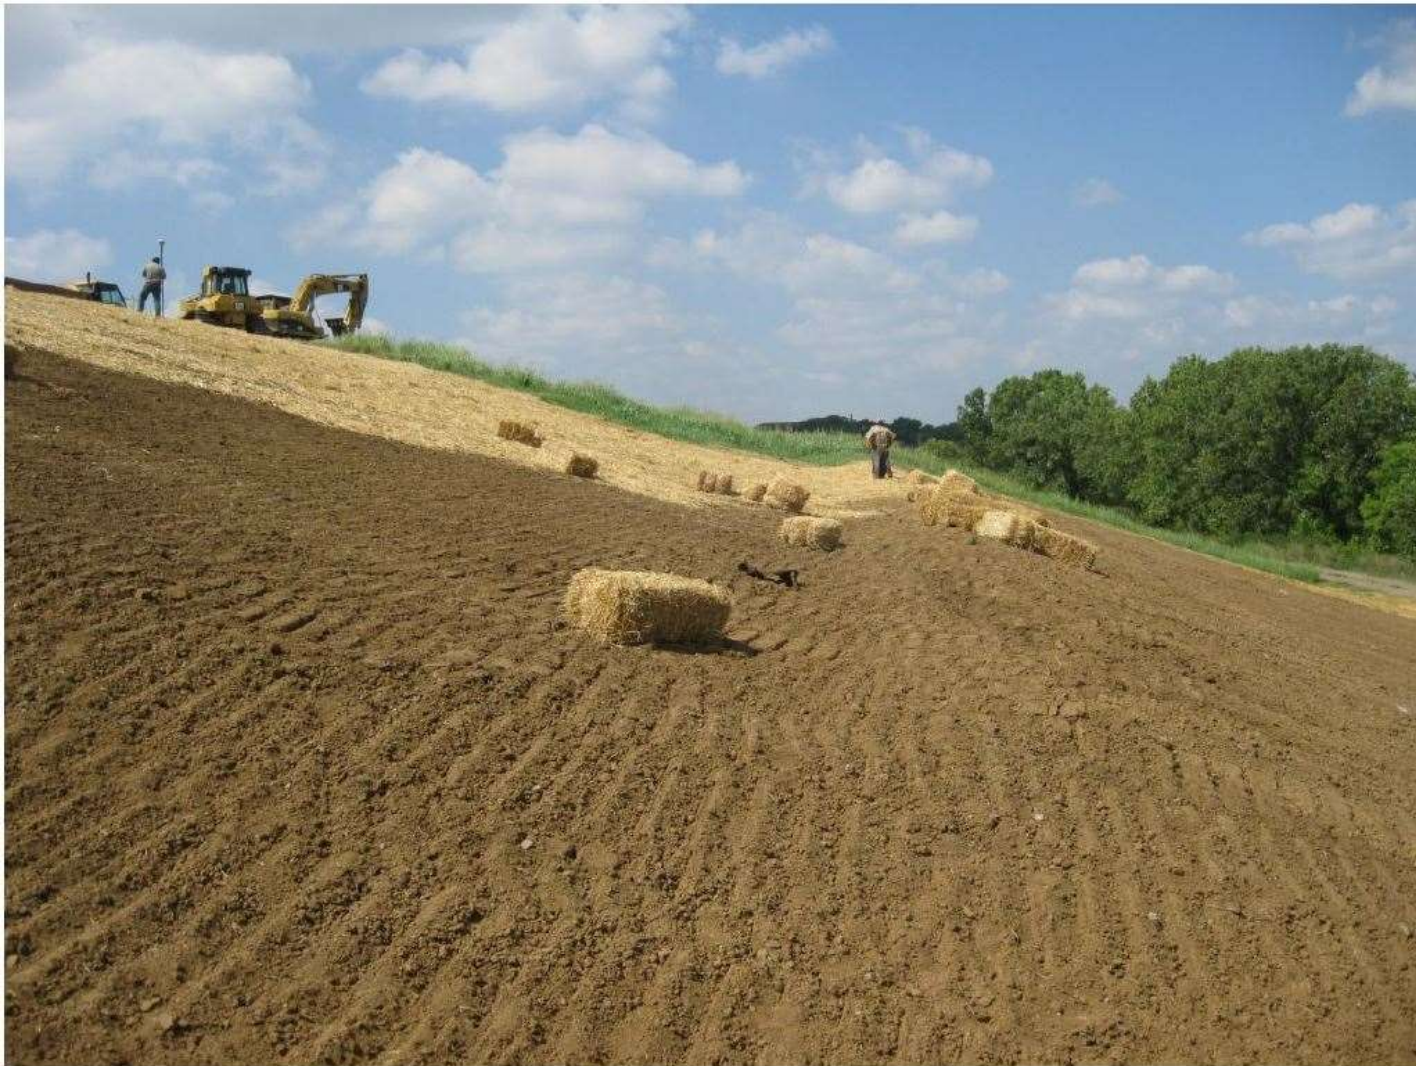
**Subarea-C, seed and straw placement**

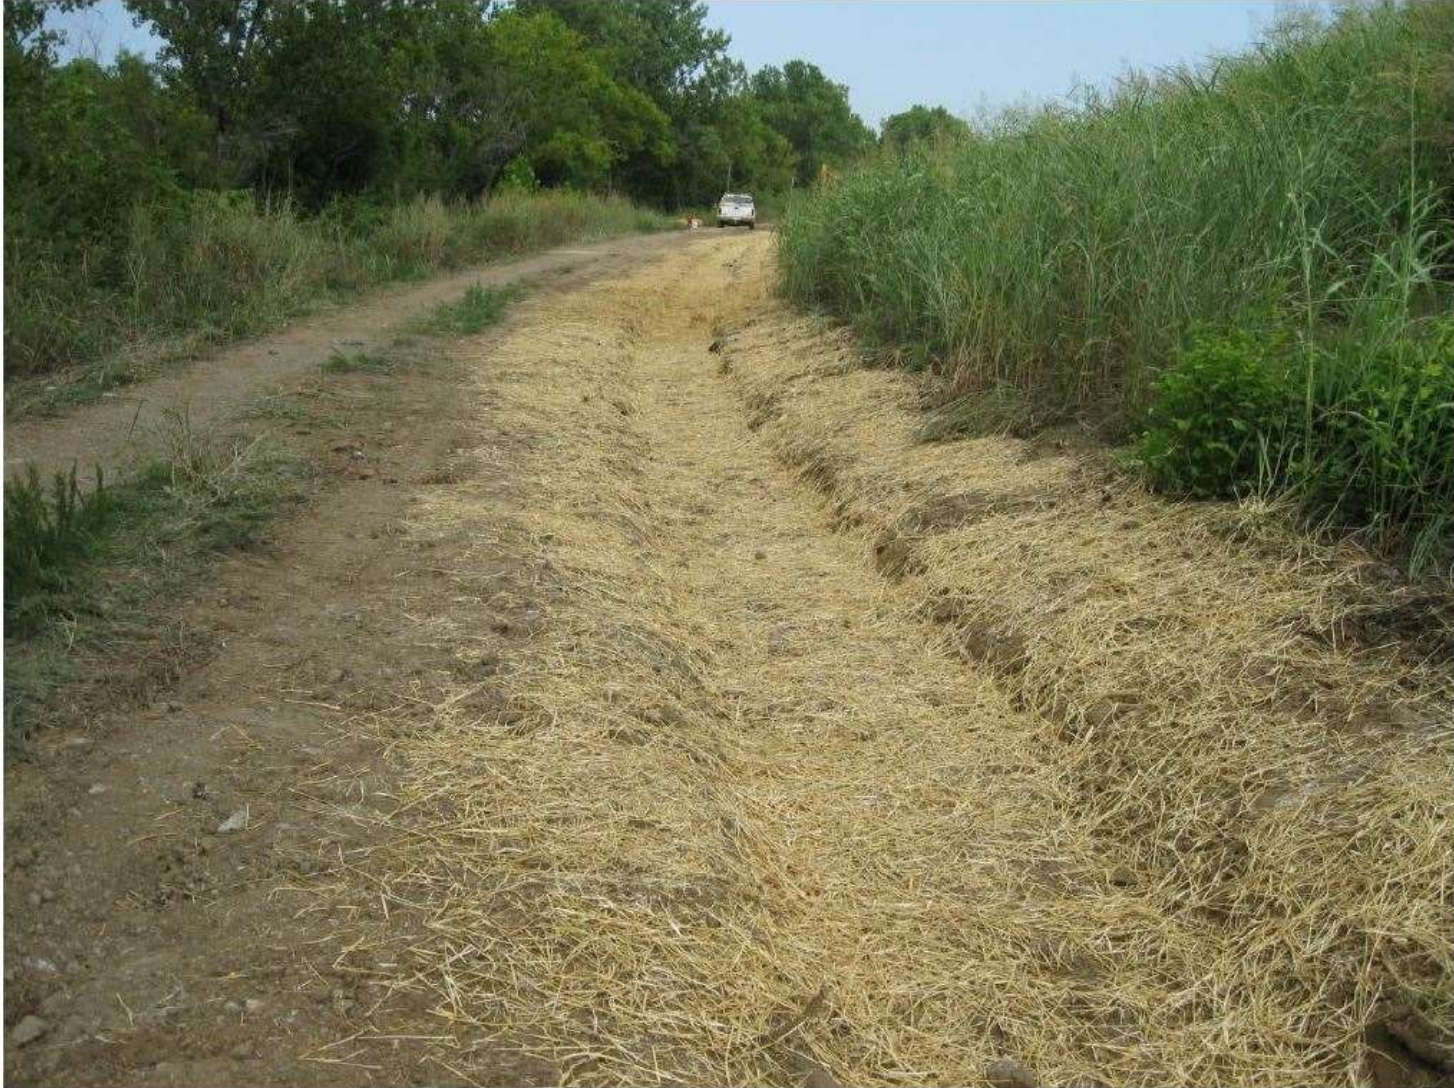
**North perimeter channel placement**

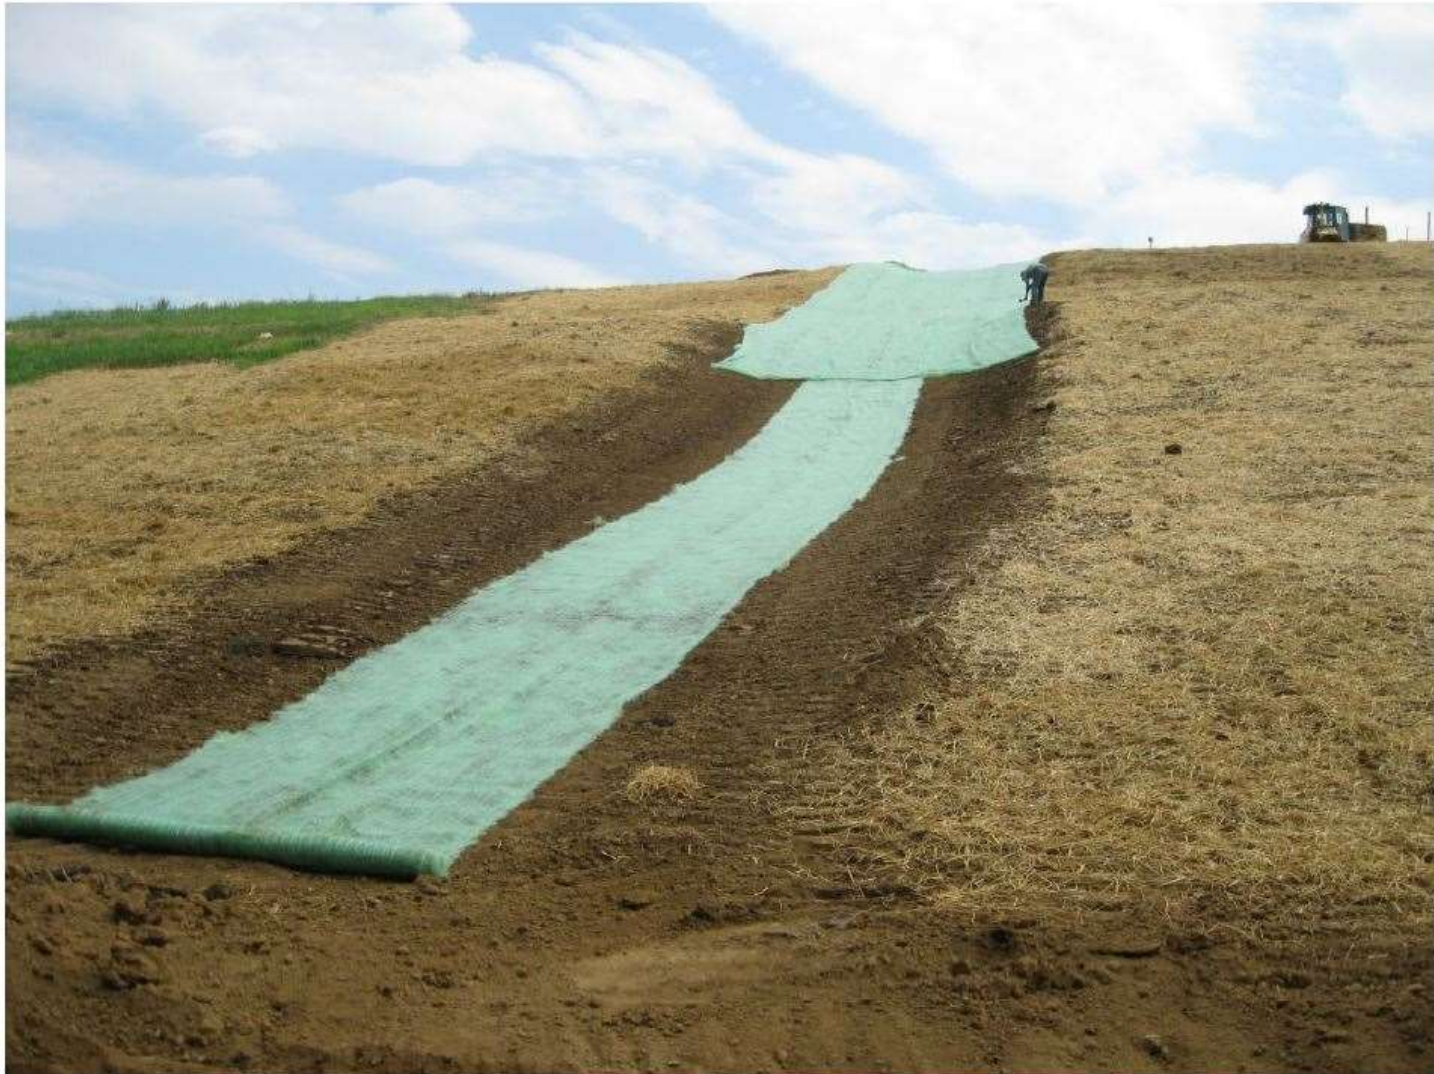
**Subarea-C, letdown structure**

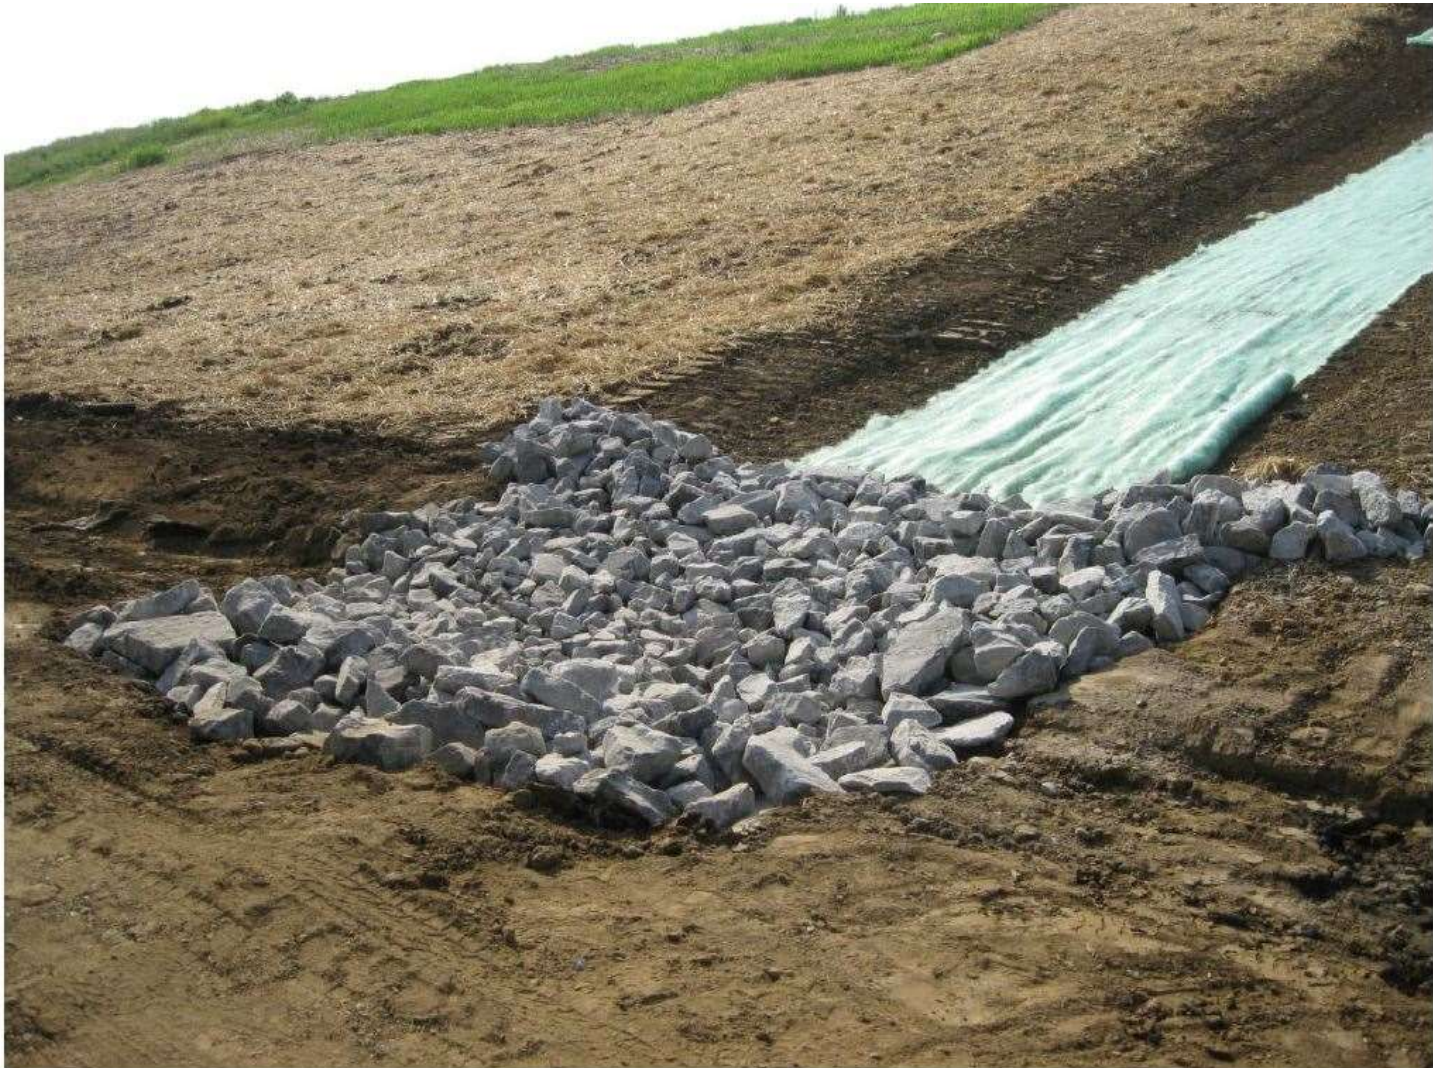
**North letdown structure, plunge pool**

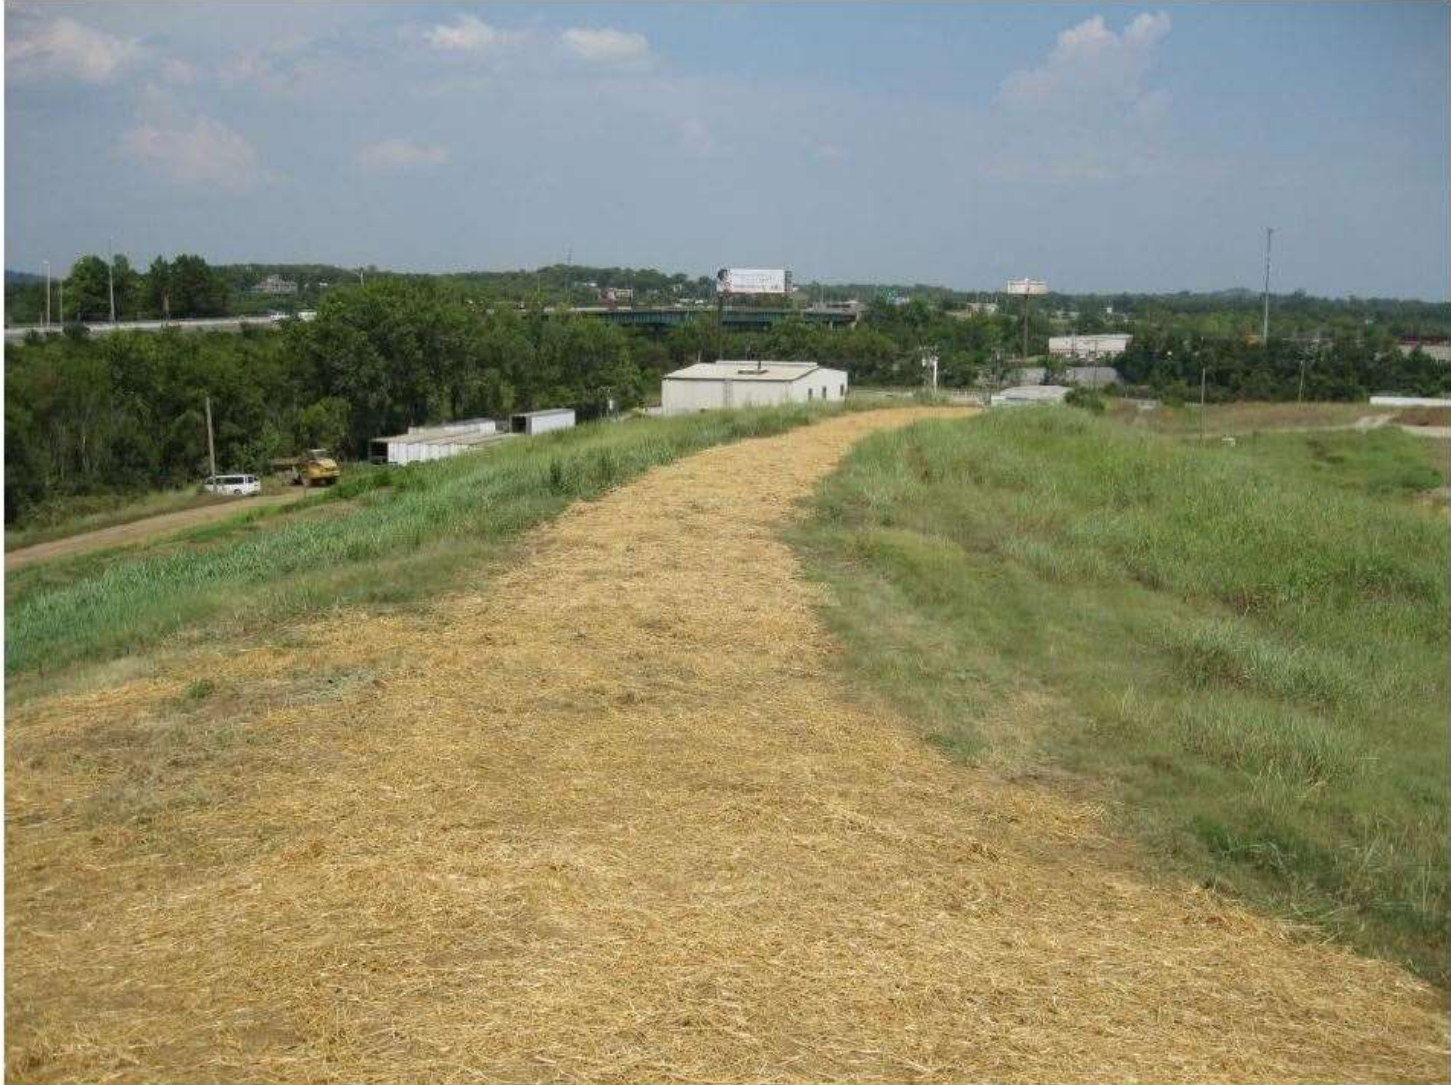
**Subarea-C, top of landfill**

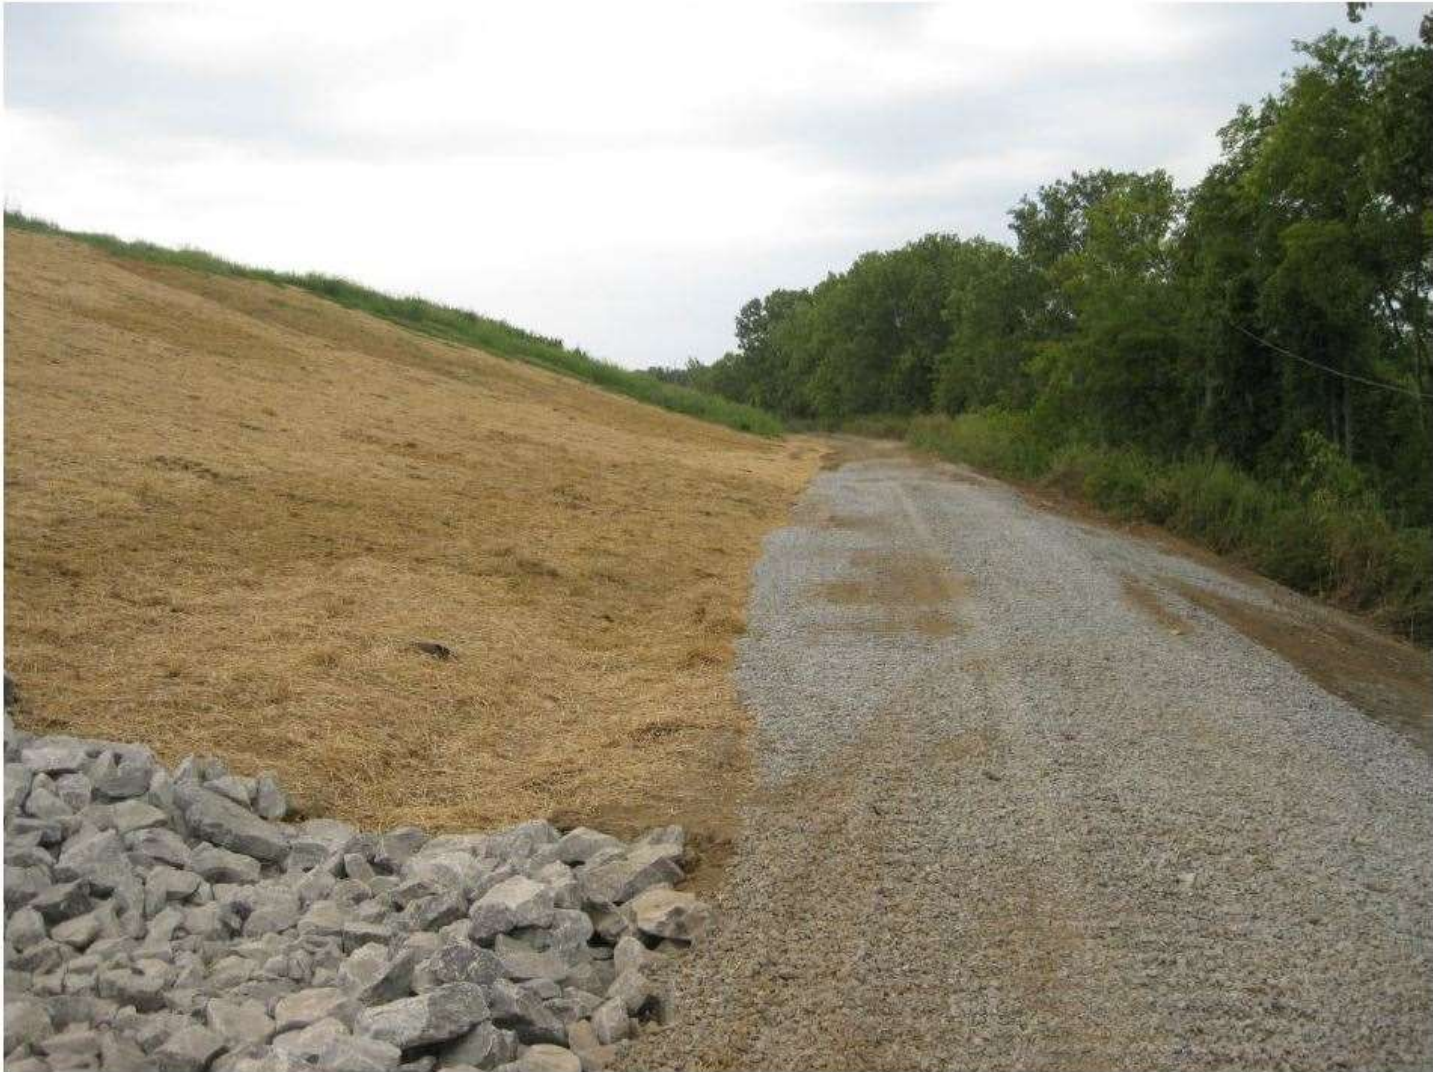
**Subarea-C straw, access road gravel placed**

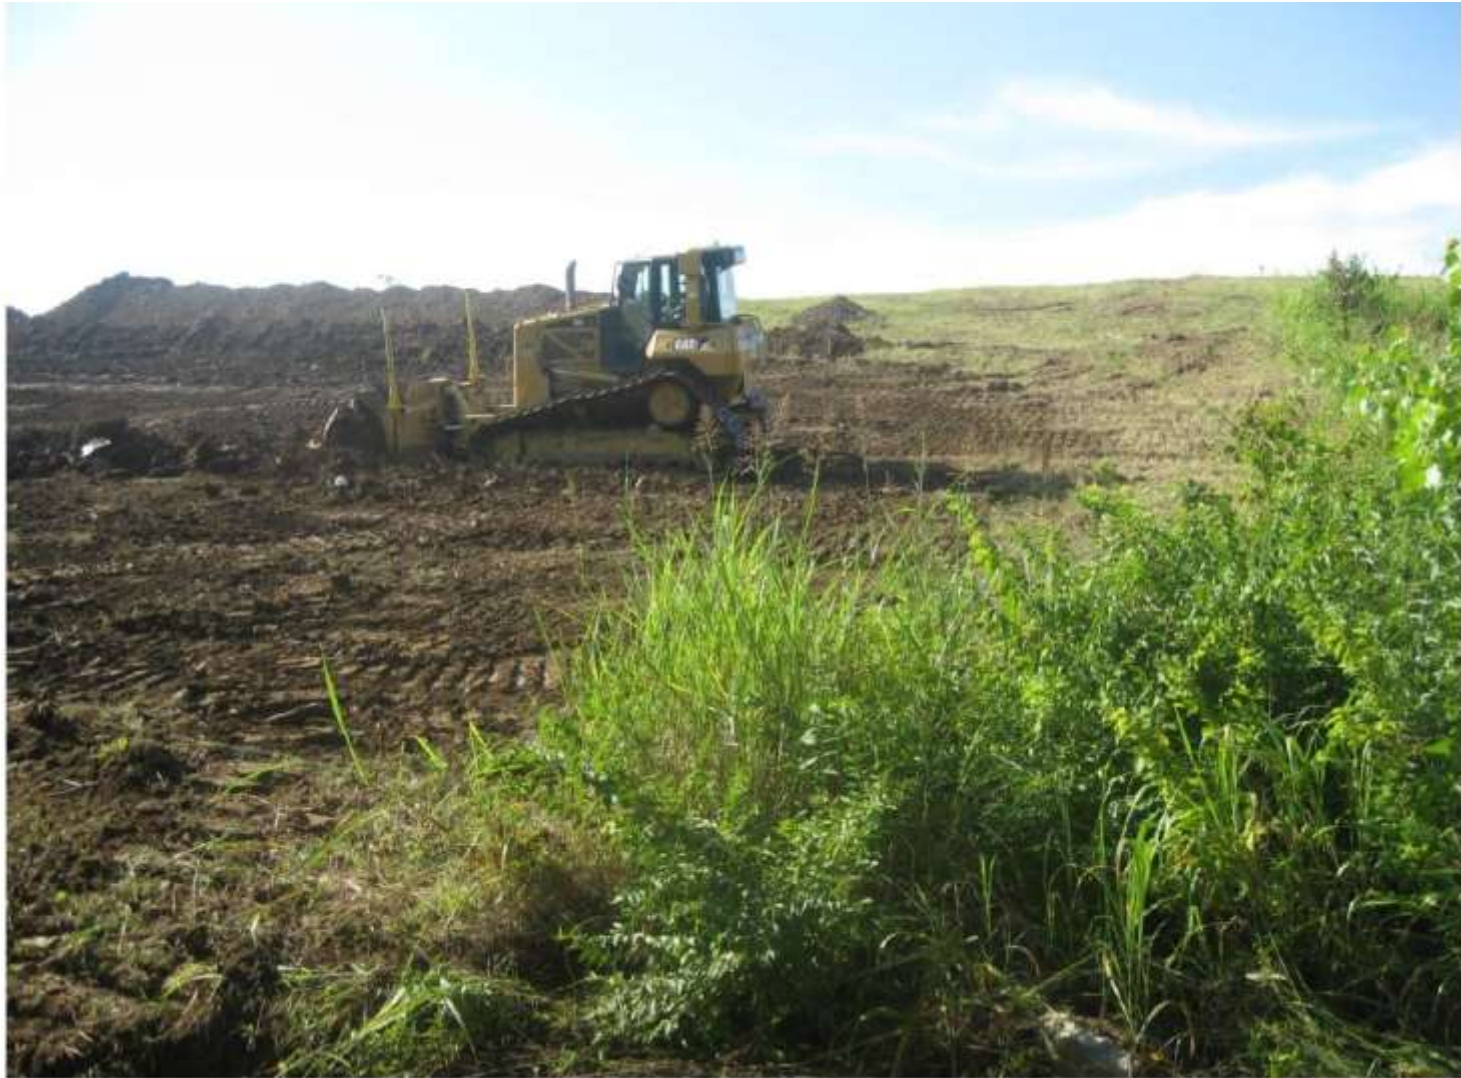
**Subarea-D, removing vegetative layer**

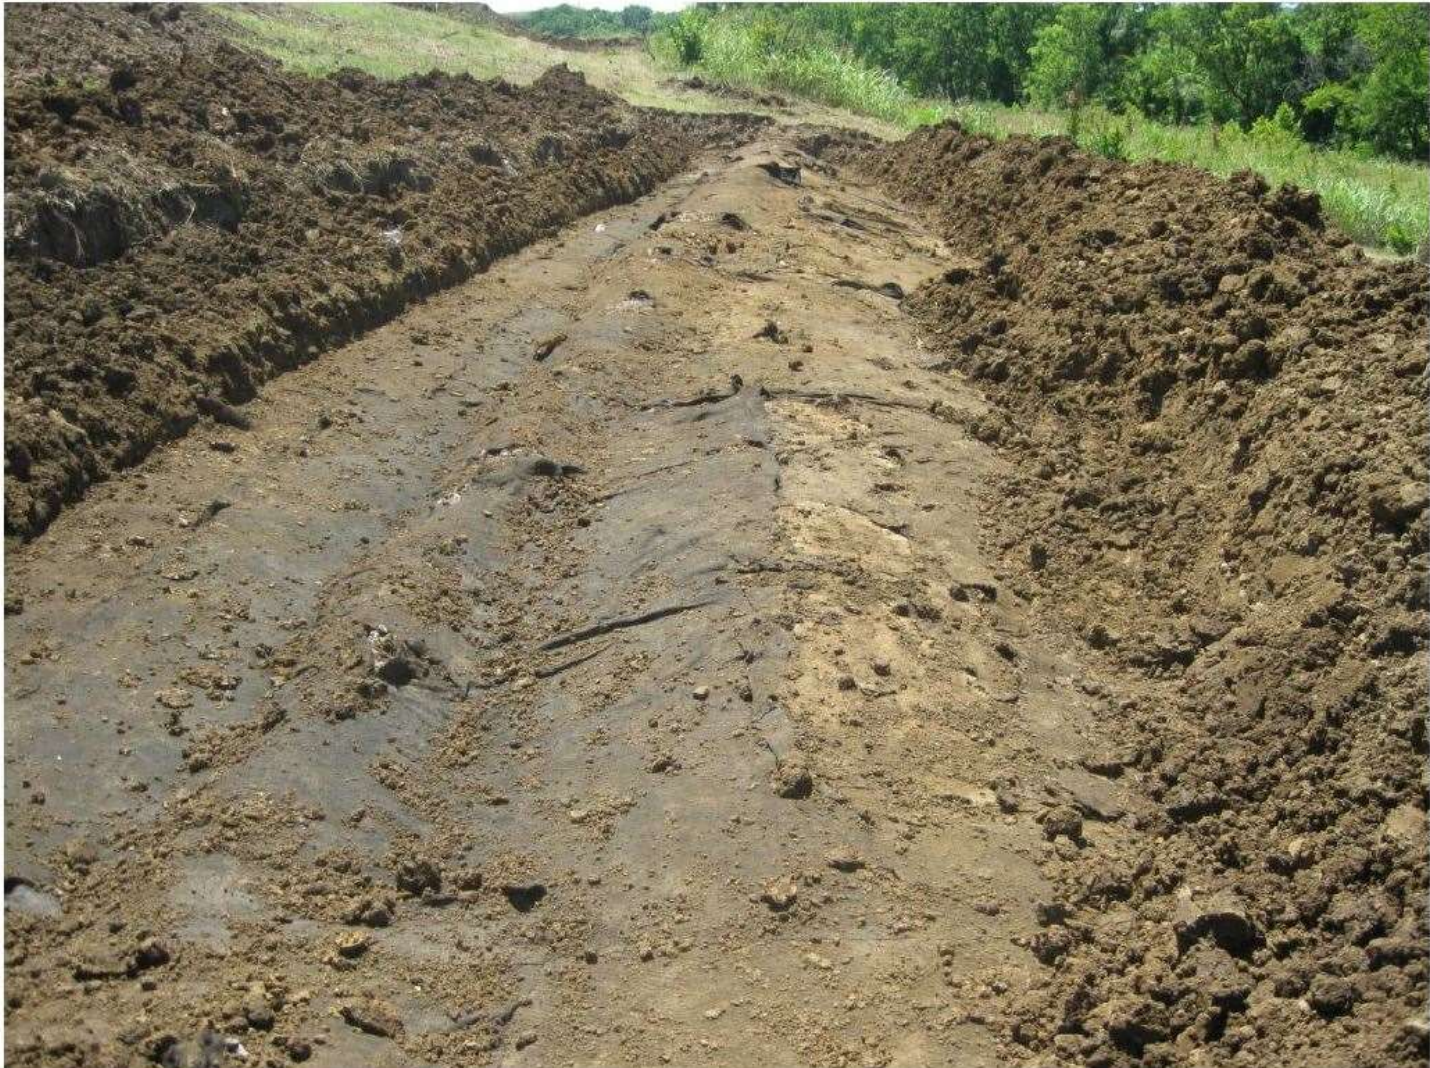
**Exposing Bench Drain, top of slope, Subarea-D, looking west**

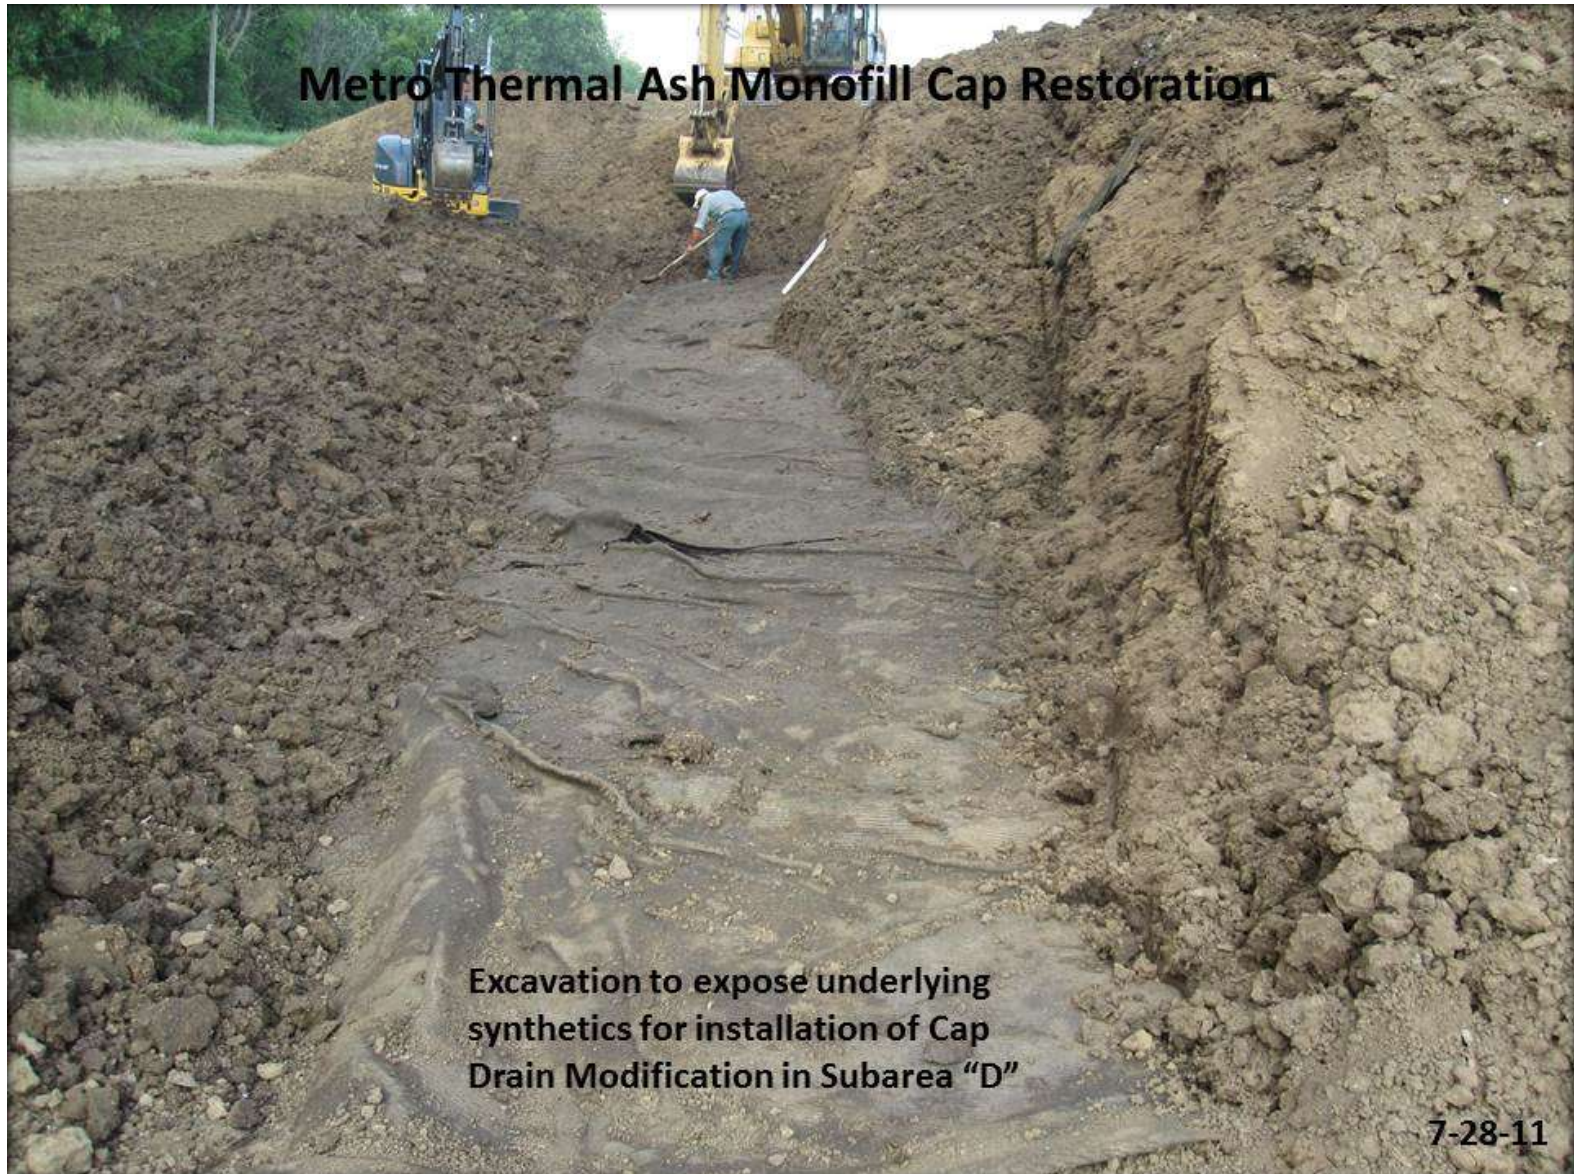
**Excavation to expose underlying synthetics for installation of Cap Drain Modification in Subarea "D"**

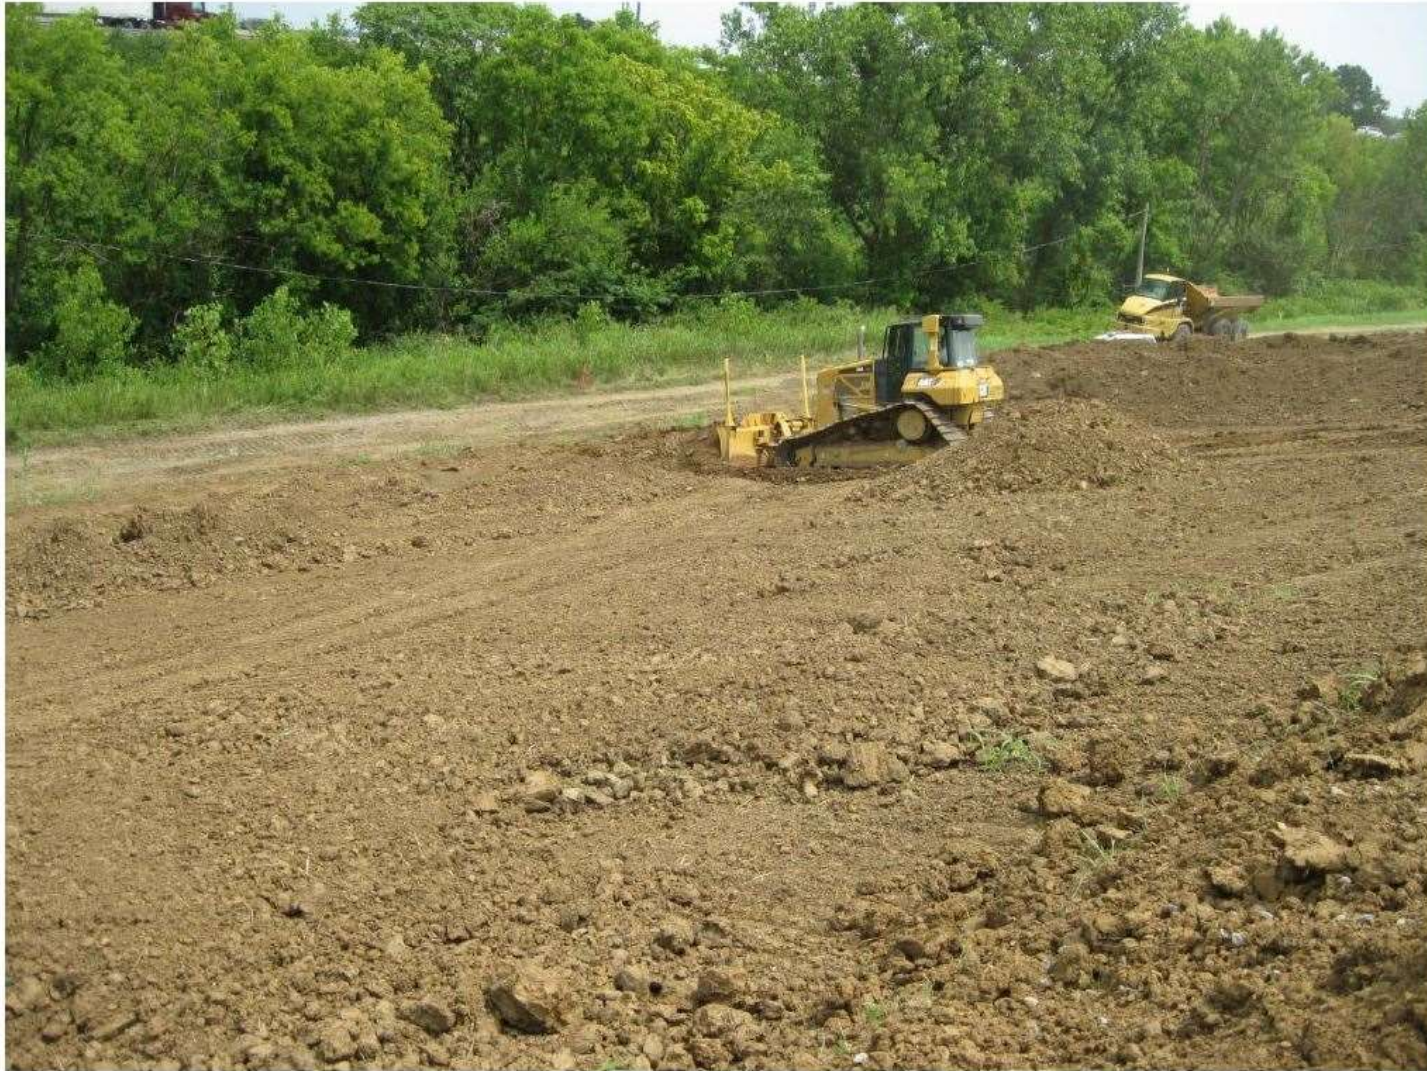
**Regrading Subarea-D**

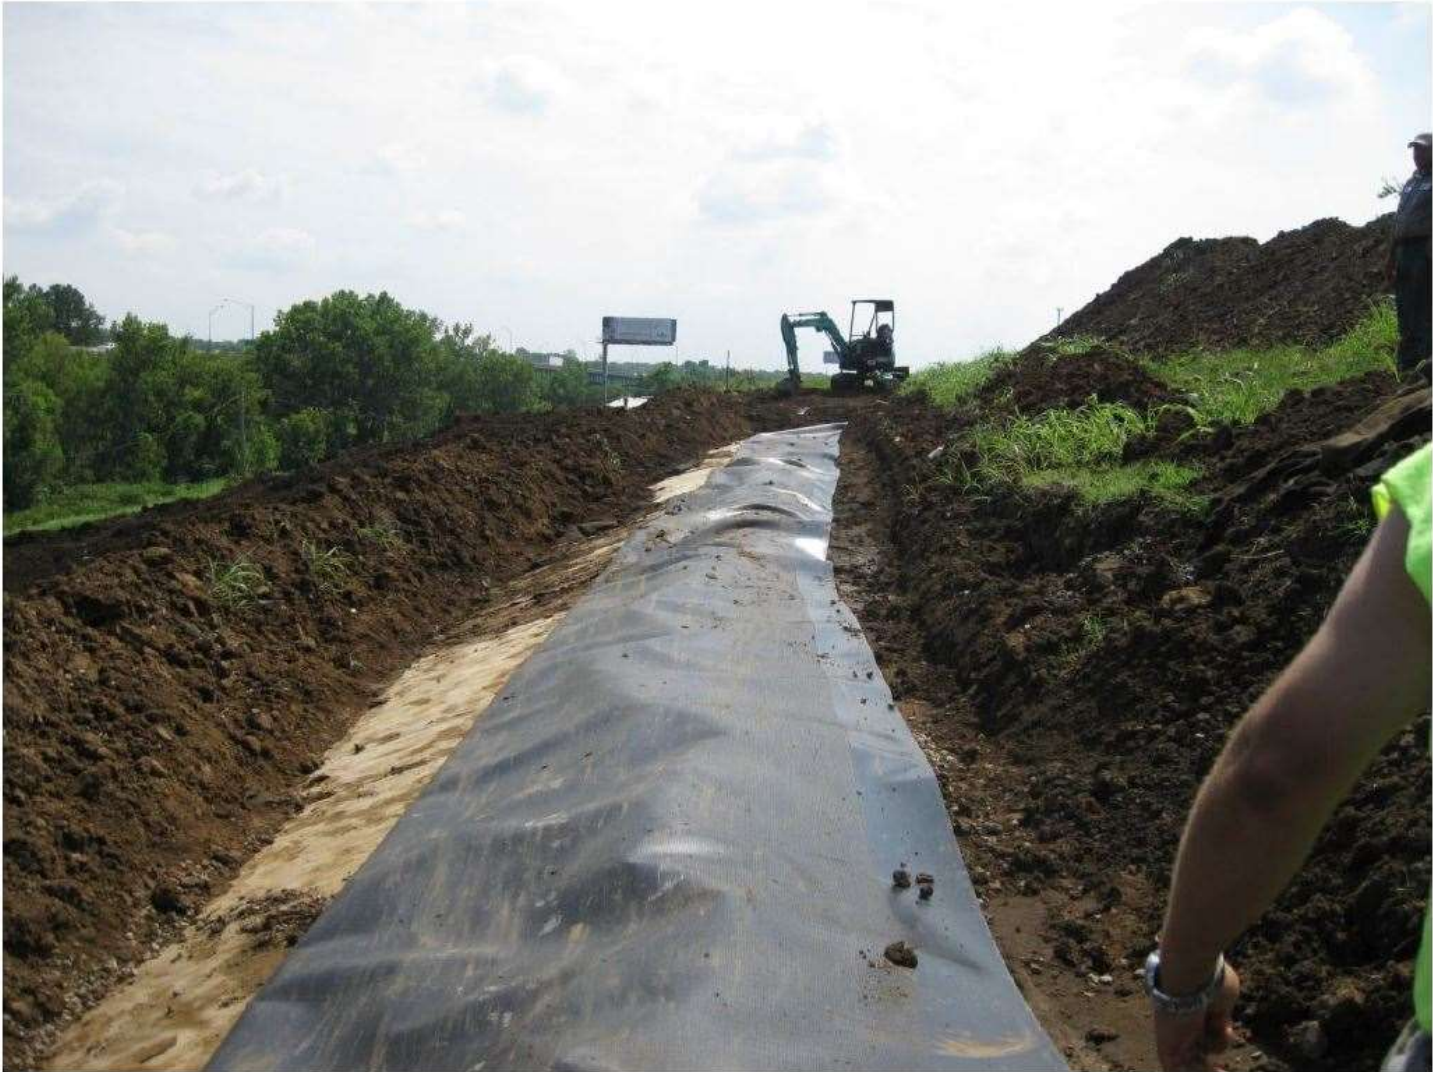
**Subarea-D, bench restoration**

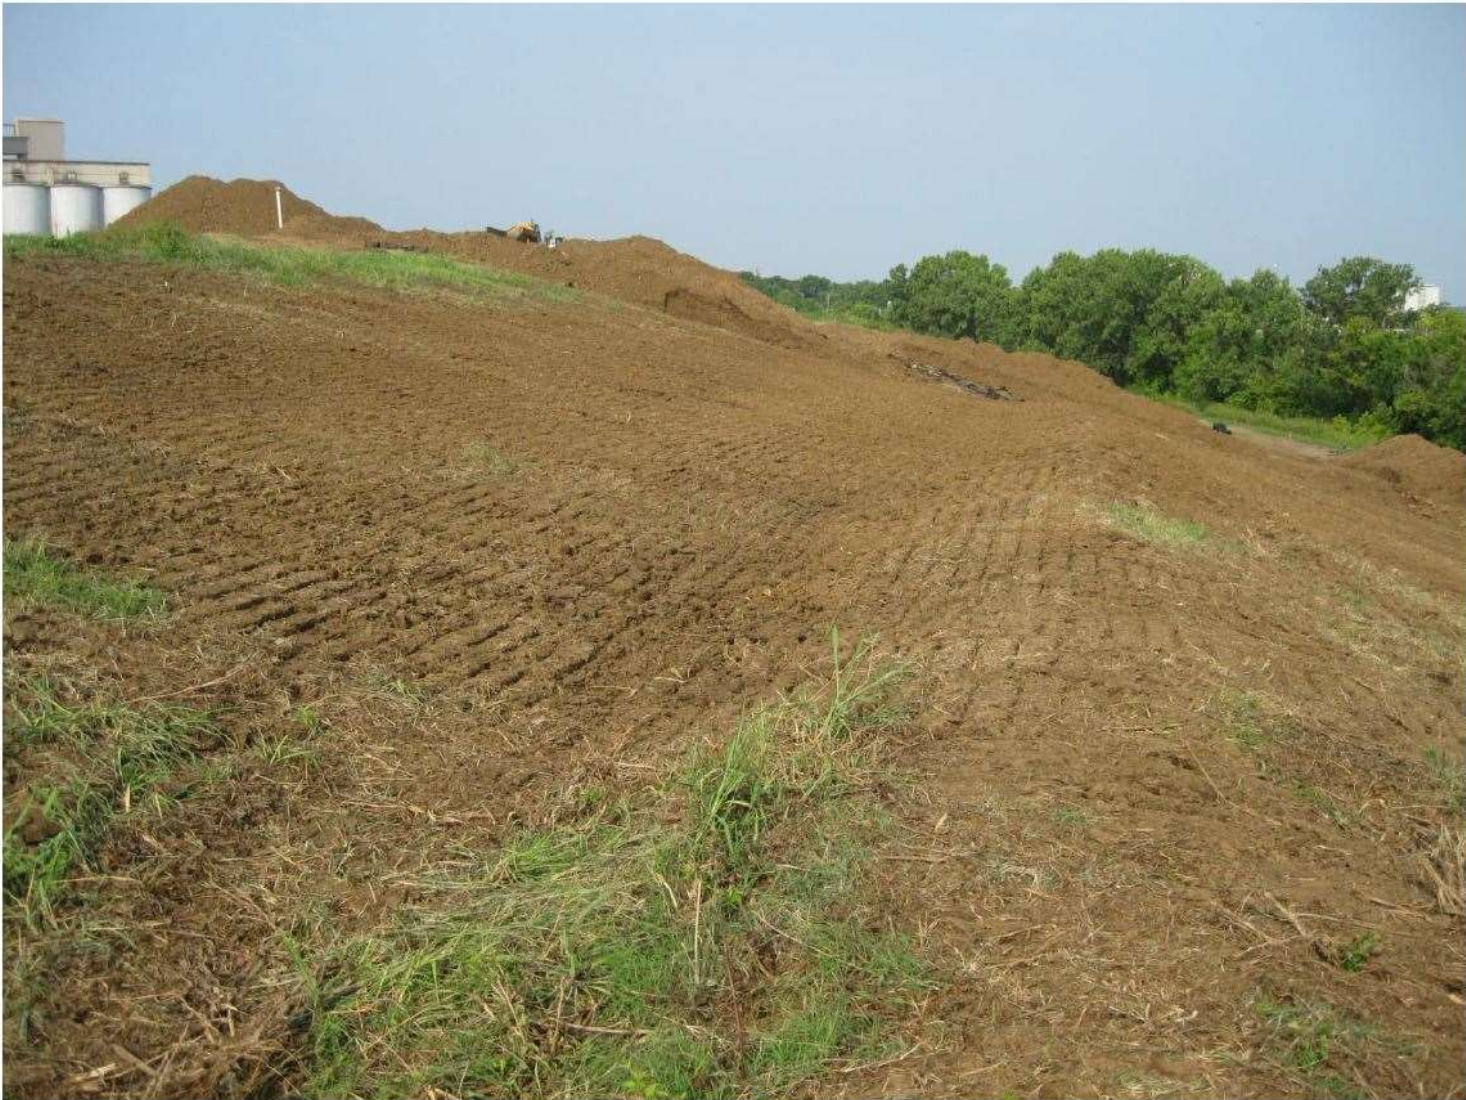
**Subarea-D, completed bench restoration. Backfilled bench, added topsoil**

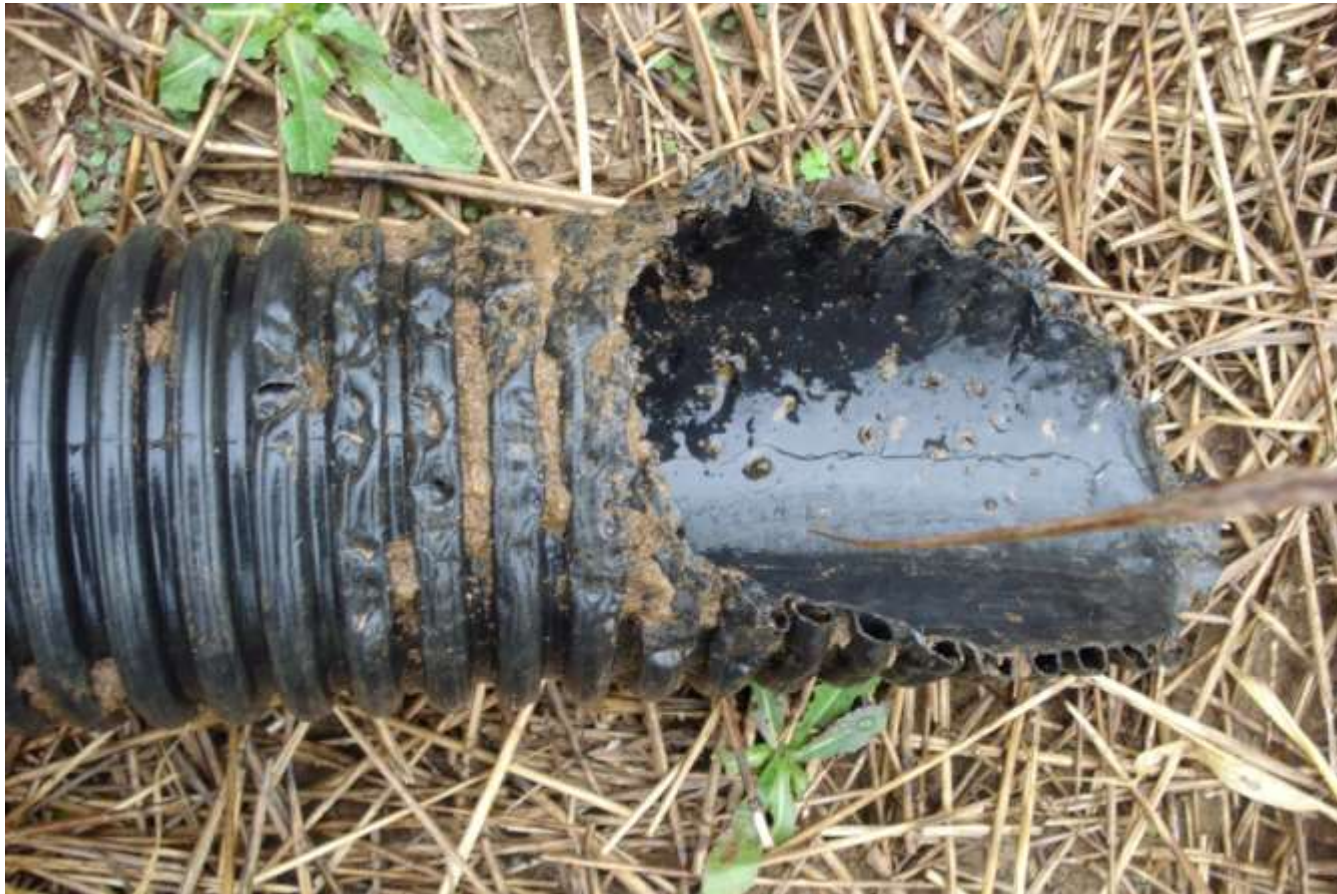
## Discharge end of Cap Drain Modification Piping
